HYDE ABBEY GATEWAY

REPORT on REPAIRS, LANDSCAPE IMPROVEMENTS and PIGEON DETERRENTS

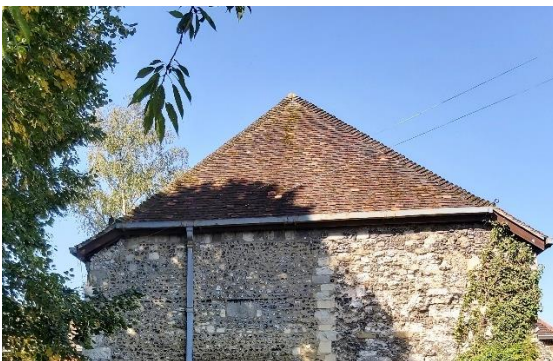
Fig 5 – View of east roof from ground level.

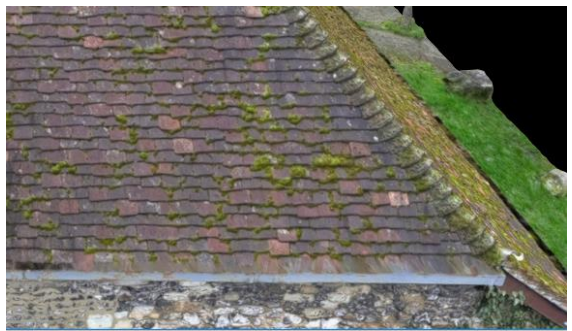
Fig 6 – Photogrammetric image of the same roof irregular tiling courses indicating failed fixings or battens.

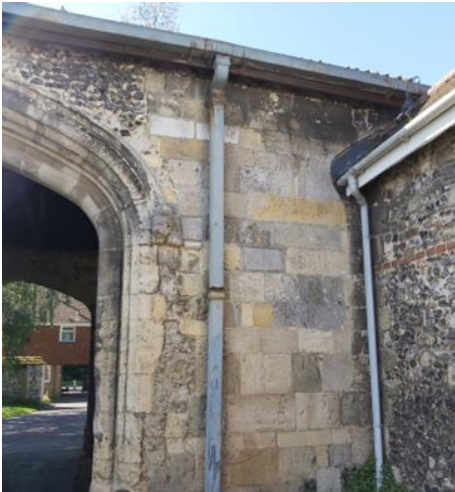
Fig 7 – Corroding downpipe on the north elevation

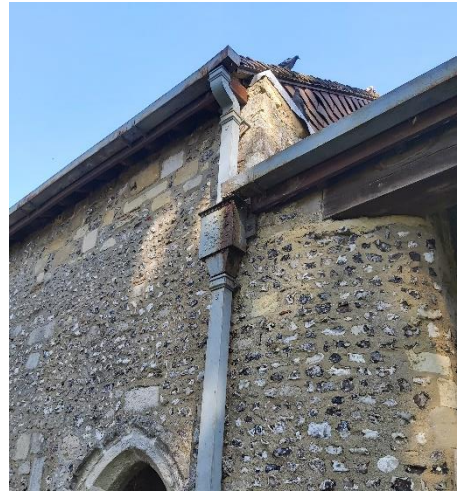
Fig 8 – Corroding hopper on the south elevation

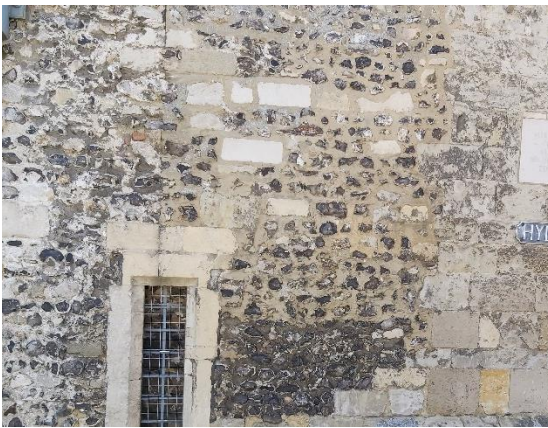
Fig 9 – Unsightly cement pointing on the north elevation

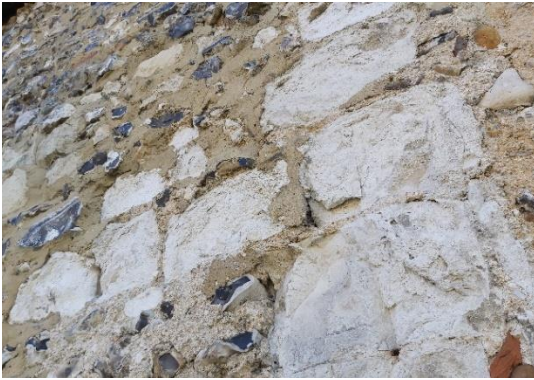
Fig 11 – Spalling ashlar stone on the north elevation.

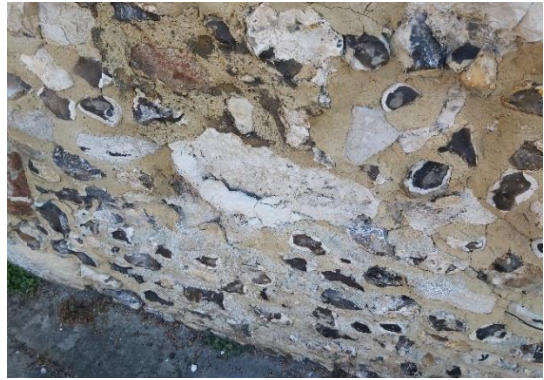
Fig 12 – Spalling ashlar stone on the north elevation surrounded by cement pointing.

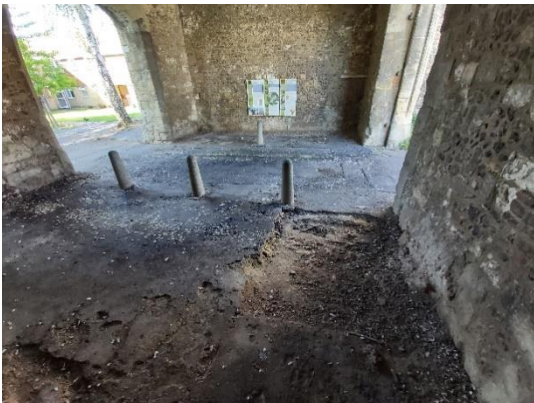
Fig 13 – Tarmac surfaces within the carriageway.

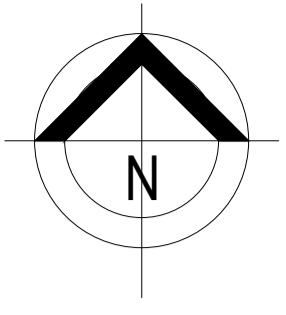
1 & 2 KING ALFRED PLACE
Eave 46.18
