Mead Cottage

1 Level 3  
1:50

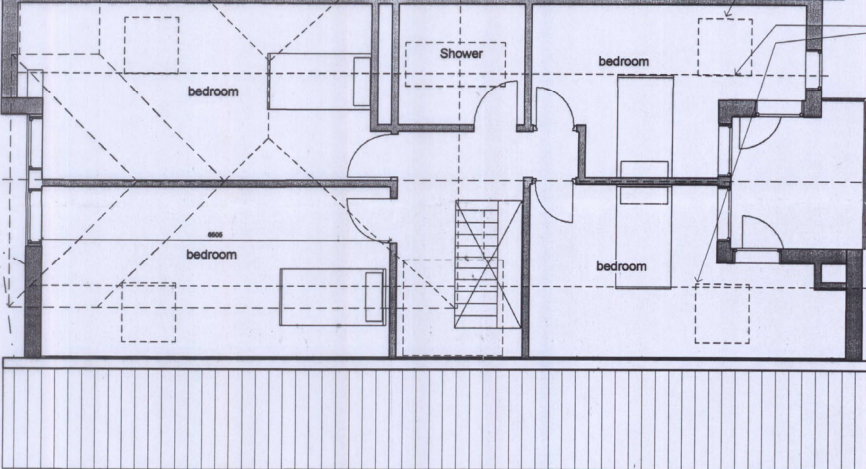
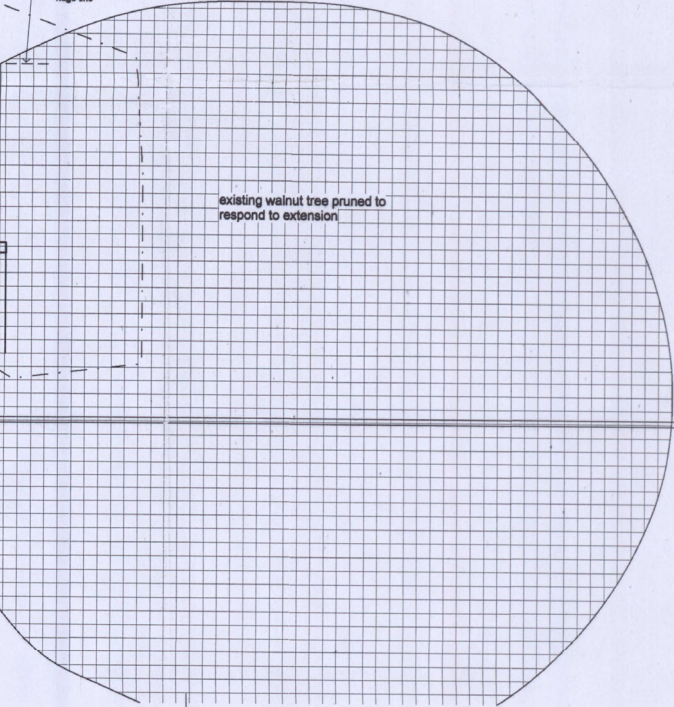
line of existing roof

line of rooflights over

line of 2000 headroom

line of balcony at first floor level, note: no balcony at attic level

ridge line

existing walnut tree pruned to respond to extension
